## Case Study 10.5 Seighford Moor, Staffordshire – changing ditch-water levels to retain species-rich plant communities

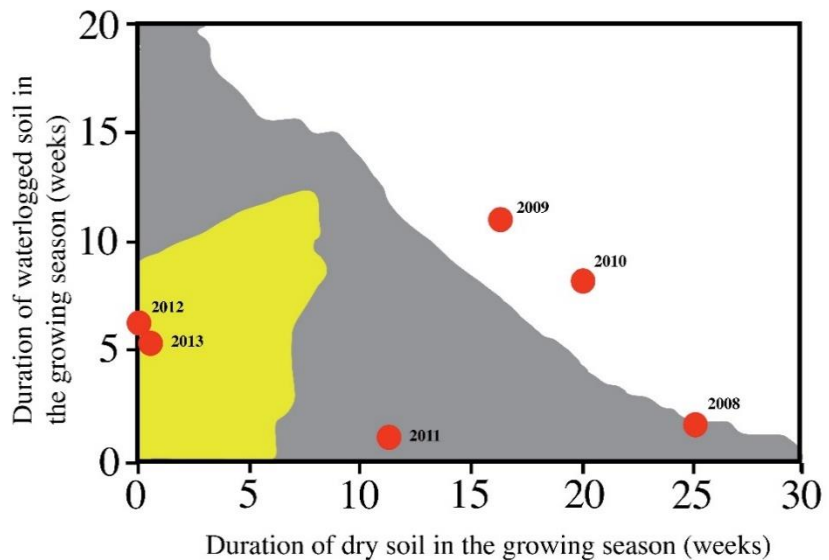
**Figure 10.6** The expected hydrological range for Kingcup-carnation sedge meadow (MG8) is shaded yellow compared to the hydrological range for all species-rich grasslands shaded grey. Annual hydrological regimes from recordings of Seighford Moor's Dipwell (S) in the period 2008–2013 (see Figure 10.5) have been plotted to show the duration of wet and dry soils during the growing season.

A review of the dipwell data from 2011 to 2013 shows that the water levels were within the expected range for Kingcup-carnation sedge meadow (MG8).

Figure 10.6 illustrates the degree to which management can affect hydrology. This site was relatively dry prior to 2008, as typified by the 2008 spot showing that 25 weeks of the growing season had water tables deep enough to cause little impact on the surface soil. The ditch levels at the site were artificially raised in 2009, producing a regime that gave around ten weeks of waterlogging during the growing season, as indicated by the 2009 and 2010 spots. This hydrological regime proved to be beyond anything previously recorded for species-rich grassland, which is represented by the grey zone in the figure. In response to this information, ditch levels were allowed to fall again, producing the moist, but not heavily waterlogged regime of 2011, which was a dry year weather-wise. The years 2012 and 2013 were very wet in terms of rainfall and their hydrological regimes as plotted on the figure show them to fall clearly into the preferred hydrological niche of Kingcup-carnation sedge meadow (MG8) (represented by the yellow zone).
